KIDSTON PUMPED STORAGE HYDRO PROJECT - LESSONS LEARNT REPORT

FEBRUARY 2024

This report will serve as a Lessons Learnt Report, discussing issues and learning with respect to the excavation of the shafts at the project.

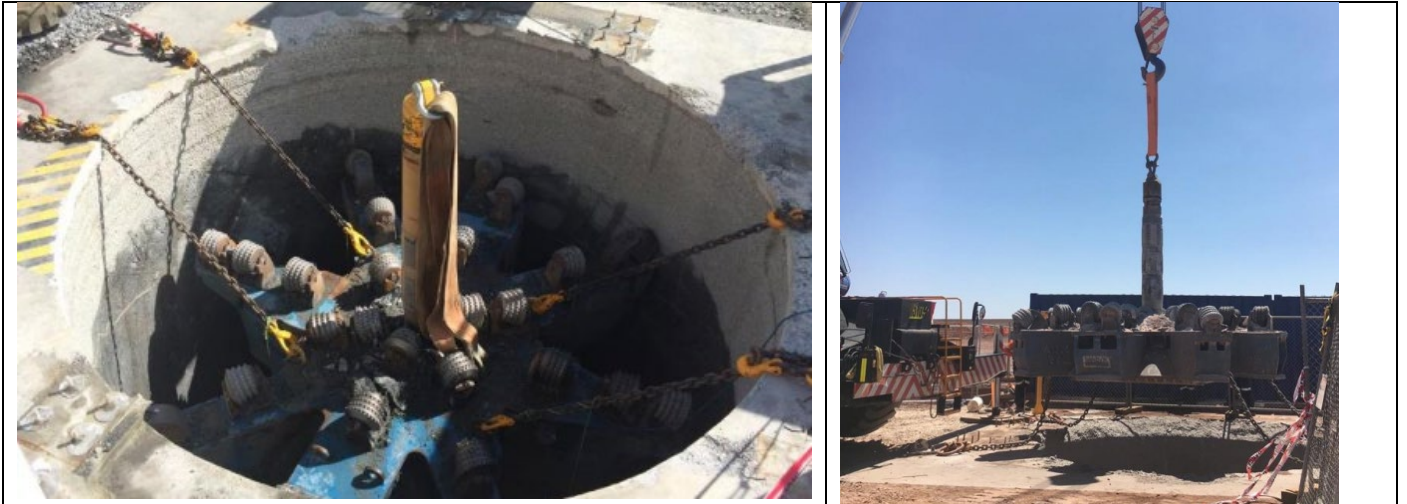
Figure 5: Reamer Head Removal

Once the reamer has excavated the entire shaft and broken through, the reamer head is removed from the surface as opposed to lowering it back down the shaft to remove from underground. This avoids the time taken to reinstall the drill strings for the lowering and prevents the potential for the reamer head to catch on the shaft wall itself. Securing the reamer head at the surface is via chains into the foundation slab at four connection points. The raisebore rig is then removed leaving the exposed reamer head held by chains. A mobile crane is then used to remove the reamer. Bunding and guarding is installed to prevent access to the open hole and fall restraint equipment is required whenever the risk of a fall exists. Signage and restricted access / barriers are used to ensure controlled access. Ground quality is then assessed after reaming by means of a drone and colour LiDar scan. Geotechnical engineers then analyse these outputs to map the shaft and provide an assessment of the excavated ground to determine whether additional ground support is required for specific features.

The key lesson learned is the methodology and safety provisions required to allow the reamer head to be removed at the surface. This ensures time and cost are minimised as opposed to attempting to lower the reamer head to an underground chamber. At 250m depth, the reattachment of drilling strings to lower and then the subsequent removal of these, is time-consuming.
